VOL. 107, 2023

# Head Checks and the Useful Life of Rails

# Zoltán Major<sup>a,\*</sup>, Róbert Horváth<sup>b</sup>, Ferenc Horvát<sup>a</sup>

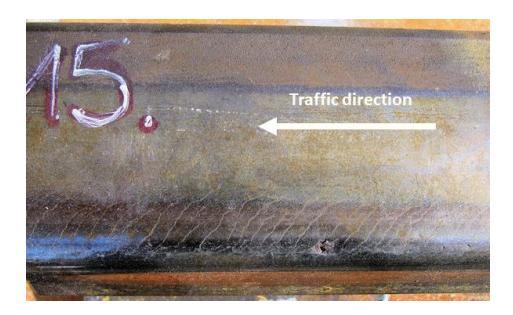
Figure 1: "S" shaped HC cracks and gauge corner spalling (Csizmazia and Horvát, 2014)

By far, the most common among the rolling contact fatigue failures are HC defects, which usually occur in the outer rail of curves with high superelevation (m > 100 mm) and in turnouts without rail inclination. HC failures can also occur in isolation but are more typically found on longer lengths of track, such as full curves lying in superelevation. The cracks are typically very close together (1-3 mm) and run nearly parallel (see Figure 1). The danger of this phenomenon lies in the fact that repeated traffic impacts can cause cracks to penetrate deep into the rail cross-section and lead to sudden rail head breakout or full cross-section rail fracture.

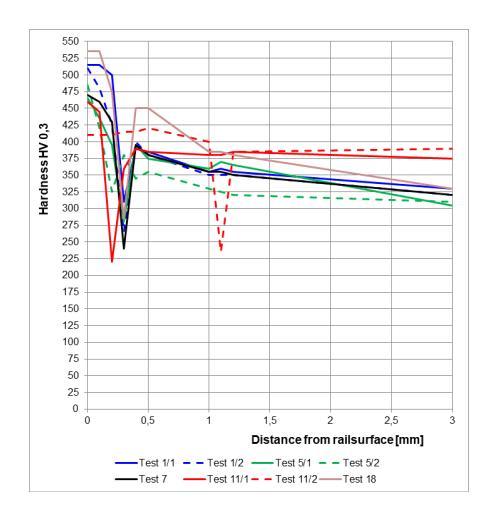
Figure 2: Results of microhardness measurements (Csizmazia and Horvát, 2014)

Depending on the class of the rail steel, a layer with about 0.4 - 1.0 mm thickness develops, cold-formed by the vehicle wheels, in which the hardness of the rail material increases very significantly, up to one and a half times the hardness of the original texture (see Figure 2). In the hardned crust, the strain capacity of the material is exhausted, leading to the appearance of cracks. After crack initiation, the presence of fluids (precipitation water, swaying engine oils) will cause cracks to grow during trains' passes due to high contact and sliding stresses. This is due to the confined fluid, which is not compressible, and in a closed crack under wheel load, very high local pressures will develop, exceeding the normal compressive stress of the rail material. The crack penetrating through the hardened crust will follow the direction of elongation of the longitudinally elongated contexture particles deeper and deeper into the rail head.

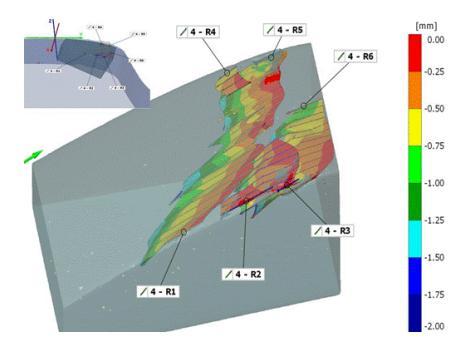
Figure 3: Crack surfaces (Csizmazia and Horvát, 2014)

The propagation of cracks in the rail head is shown in Figure 3, and the theoretical stages of crack growth are shown in Figure 4.

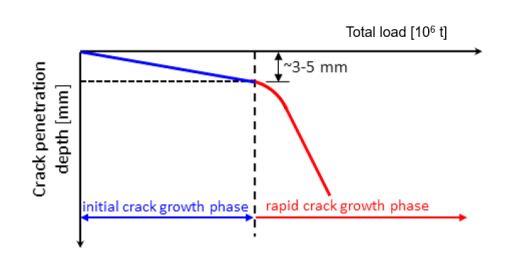
Figure 4: Crack growth phases

The rail is the most expensive part of the railway track. Its manufacture and installation is a major logistical challenge, requiring considerable technical expertise, as it involves moving and installing 120-metre-long rails in one piece. The maintenance of sections affected by HC defects requires a method that is capable of removing the damaged parts to just the necessary extent. The basis of any modern maintenance strategy is a high-level measuring technique in order to detect defect locations and defect depths as accurately as possible (Mićić et al., 2023). According to the Hungarian annual measurement programs, depending on their traffic load, each railway line is subjected to one or two ultrasound, rail profile, equivalent conicity and eddy current measurements done by a track survey train. The combination of the different techniques is necessary because only by using them simultaneously can a proper picture of the depth of the defects be obtained. Once the measurement results have been processed, the rail machining plan for the next semester or year is determined. On high-traffic tracks, rail failure caused by HC defects is inevitable without regular rail maintenance (rail grinding or rail milling). Since beyond a certain failure depth (3-5 mm), the progression of HC defects penetrates steeply into the rail head (see Figure 4), only a defect removal procedure or rail replacement can repair the damaged rail when this value

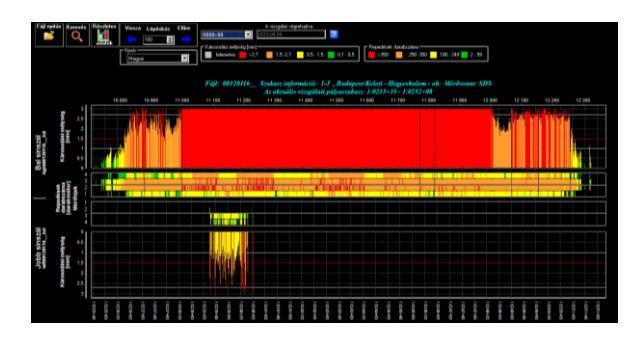
Figure 5: Results of eddy current measurements

A good example is the railway line Budapest – Hegyeshalom border, section between 235+35 – 252+08 hectometer section number. The outer rail of the curved right track was replaced in 2011. Figure 5 shows the eddy current measurement in April 2016, with HC defects of critical depth in the sections marked in red. In this case, a small correction is no longer sufficient, and the consequence of not having done the maintenance may be a very costly rail replacement. Taking the curve shown as an example, we examined the useful life of the rails and the resulting maintenance costs for two possible strategies. In the case elaborated, we considered the annual average wear rate characteristic to this track section to be 0.4 mm and the previously measured progression rate of HC defects to be 0.7 mm/y. According to Hungarian standards, after being subjected to a certain amount of wear and gross tons of traffic load, the rail can be moved to a lower-class railway line, where it can remain on the track for several years, which is called second lay. The rail is also the most "expensive" component in terms of its ecological footprint, i.e., the most polluting component in terms of its production, transport, and installation, so bearing in mind the life cycle emissions, it is important to prolong its life cycle as much as possible.

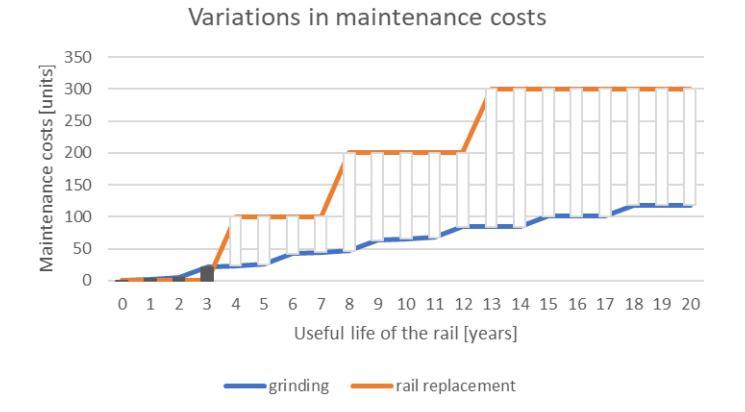
Figure 6 shows the variations in annual maintenance (grinding) and rail replacement costs. In the case where the operator carries out the grinding works according to a good strategy, the total cost in the fourth year is 23.4 units. In contrast to replacing the rails at a cost of 100 units, this is much less expensive while keeping the original rails in service. By the eighth year, the total cost is still only 46.81 units compared to 200 units for rail replacement. It is evident that timely maintenance has a significantly more favourable impact on life-cycle costs. Over 10 y, the total life-cycle costs are 70 % lower, and over 20 y they are 60 % lower. In terms of ecological footprint, it is obvious without any serious calculations that regularly maintained rails are significantly more beneficial than replacing them. If diagnostic and repair technologies are properly applied in the development of maintenance strategies for transport infrastructure, a significantly more sustainable operation of the infrastructure can be achieved. By extending the useful life of individual infrastructure elements, in this case, the rails, as much as possible, the life cycle costs can be minimised, and the environmental impact can also be significantly reduced.
